Pakefield Monthly Monitoring Report

Date & Time of survey: October 29, 2024 12:18 Time of Low Tide: 13:45 Height of Low Tide (m ODN): -0.7 Reason for Inspection: Scheduled

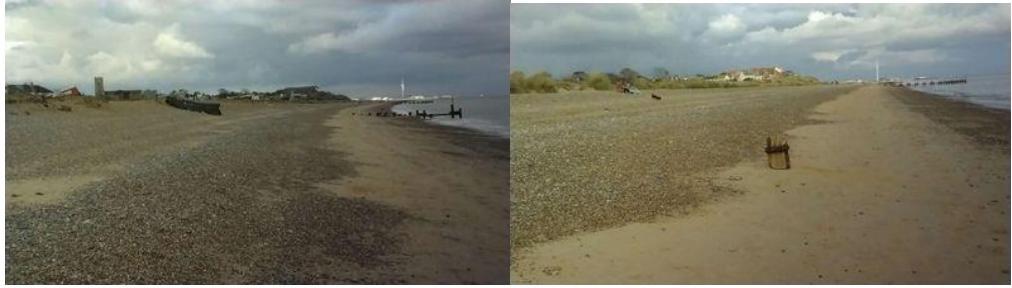
Beach photos looking north:

Extension of beach cliffing alongshore: Negligible change

Landward recession of beach cliff: Negligible change

Change in gradient of beach cliff face: In places gradient steepened where there has been wave action at toe Maximum height of beach cliff (m): 2

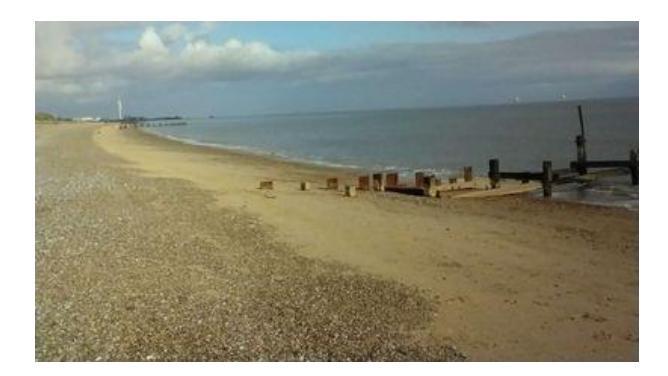
Image of exposed timber groyne:

Change in beach level relative to exposed timber groyne opposite Grand Avenue: Negligible change

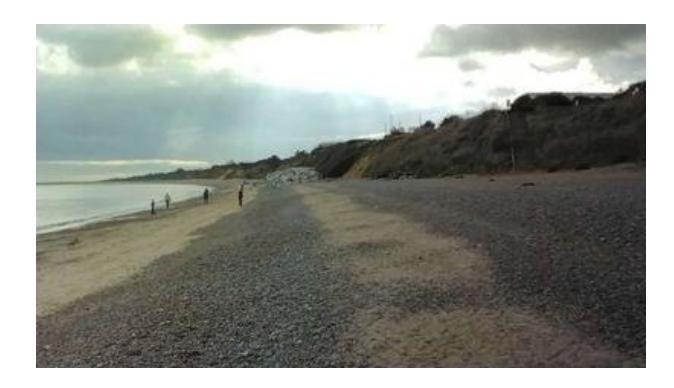
Images of beach north of Arbor Lane:

General impression of beach volume: Moderately decreased

Comments on change in beach geomorphology: High tides noted above reached landward of the Mean High-Water Mark MHWM and reprofiled the beach. A shingle berm remains but is much less substantial. In places the base of the dune face appears to have been reached, which has not caused significant erosion but has increased the face gradient, and relative height. The foreshore overall retains a typical relatively steep gradient although there has been some recent improvement in its lower levels.

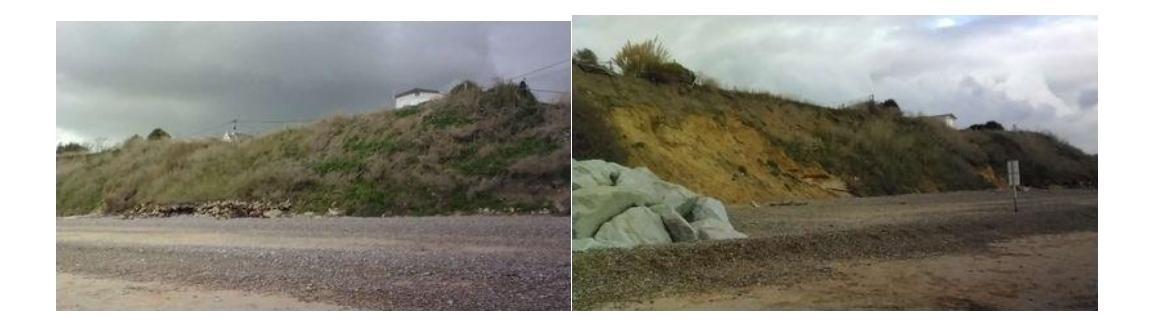
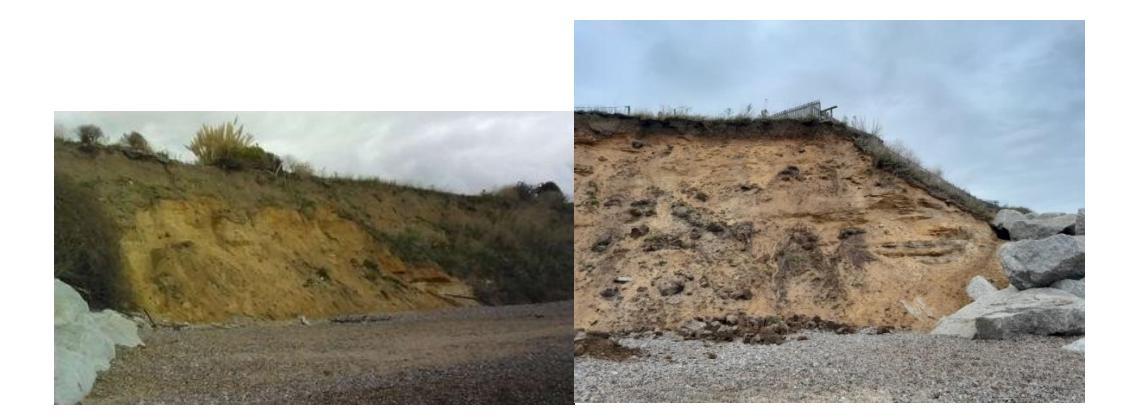
Changes to soft unconsolidated sand cliffs north of rock armour: Slumped material on cliff face; denuding and loss of vegetation; cliff-face steepening and overhanging; scree at base of cliff; fallen vegetation at base of cliff.

Changes to soft unconsolidated sand cliffs south of rock armour: Slumped material on cliff face; denuding and loss of vegetation; evident cliff top recession; cliff-face steepening and overhanging; scree at base of cliff; fallen vegetation at base of cliff.

Comments: Seas probably reached the cliff bases to the north and south side of rock, and caused some disturbance. The upper beach level, near the base of the cliffs remains relatively healthy, particularly on the south side of the rock. The ongoing processes of gradual cliff loss have continued where faces are steepened. The fencing above the south end of the rock is becoming undermined.

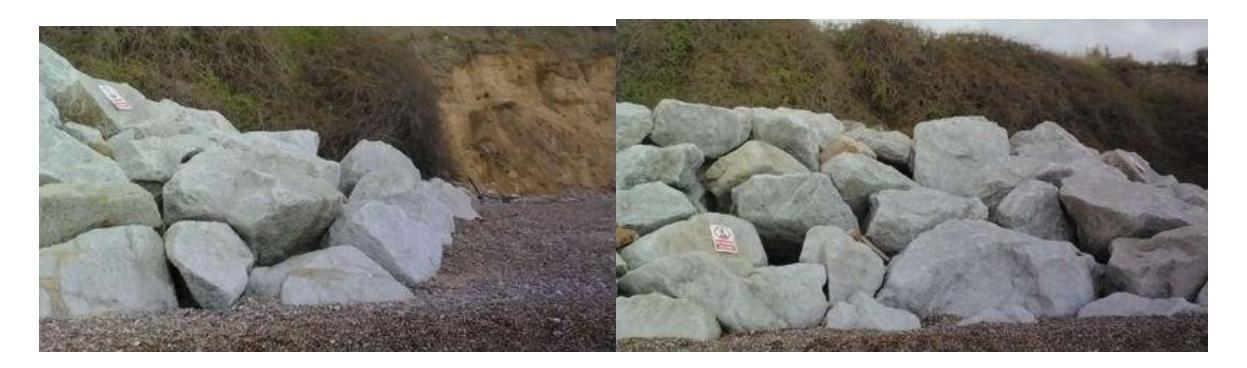
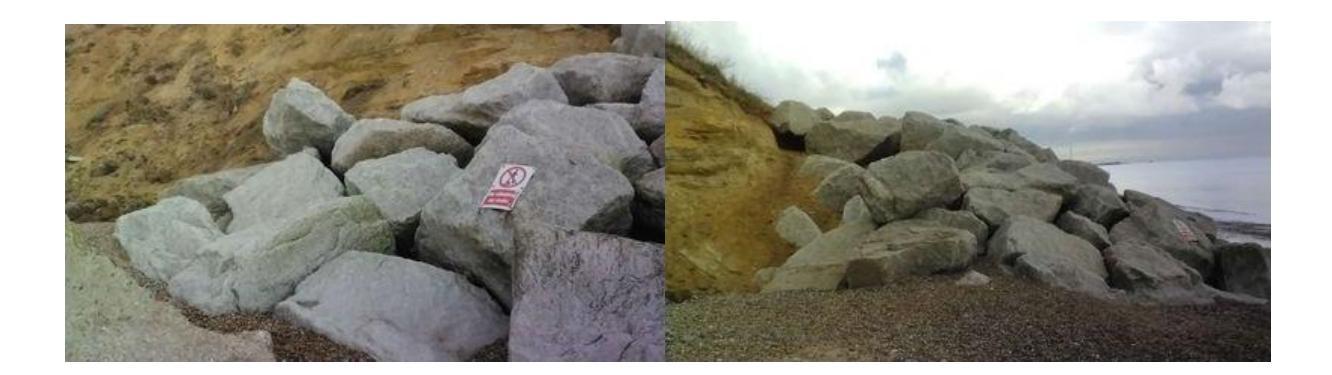
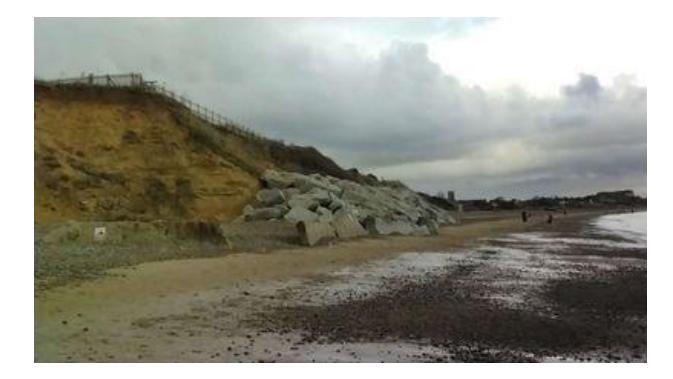
Photos of rock armour:

Packing of rock: Overall satisfactory

Beach levels surrounding rock armour: Average

Beach access around the rock armour: Dry access available past rock armour around times of low tide **Exposure of geotextile:** Being monitored

Hazards/debris within structure: Being monitored

Stability of cliff behind rock armour: As previous, no obvious or significant change apparent behind the main body of the rock structure, as viewed from the beach (vegetation growth obscures part of the cliff face). **Asset condition grade:** 2 Good; rock armour condition satisfactory; no change in protection

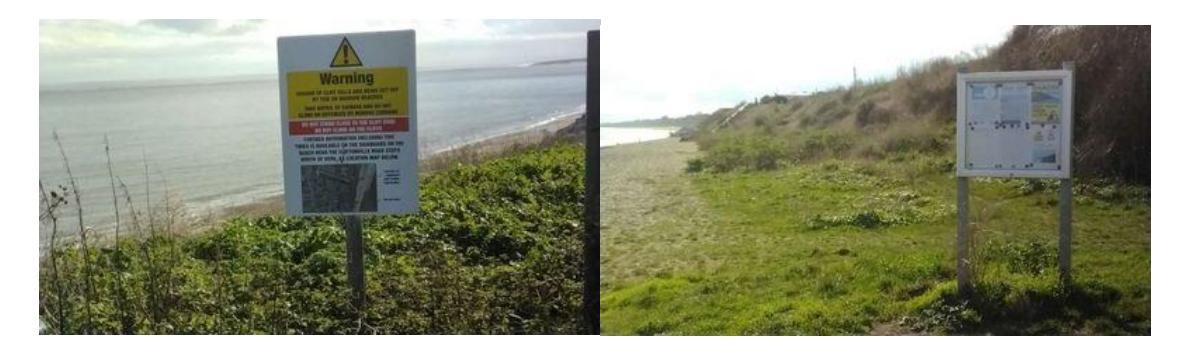
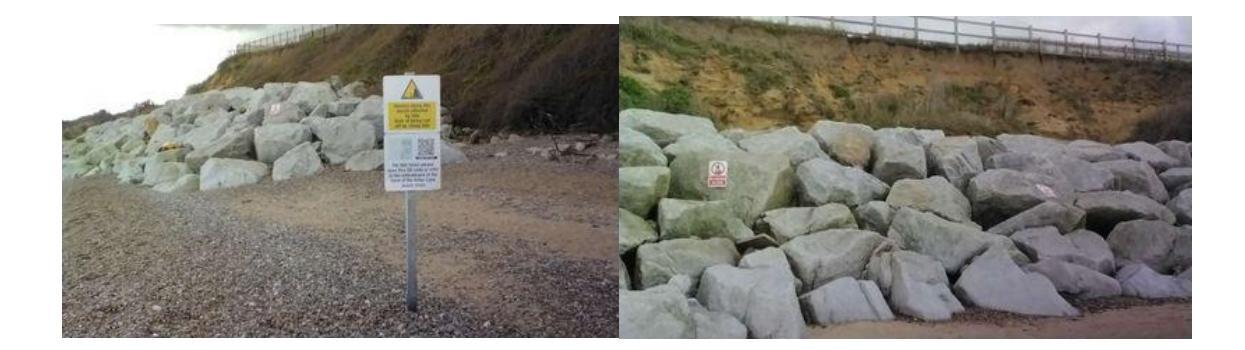
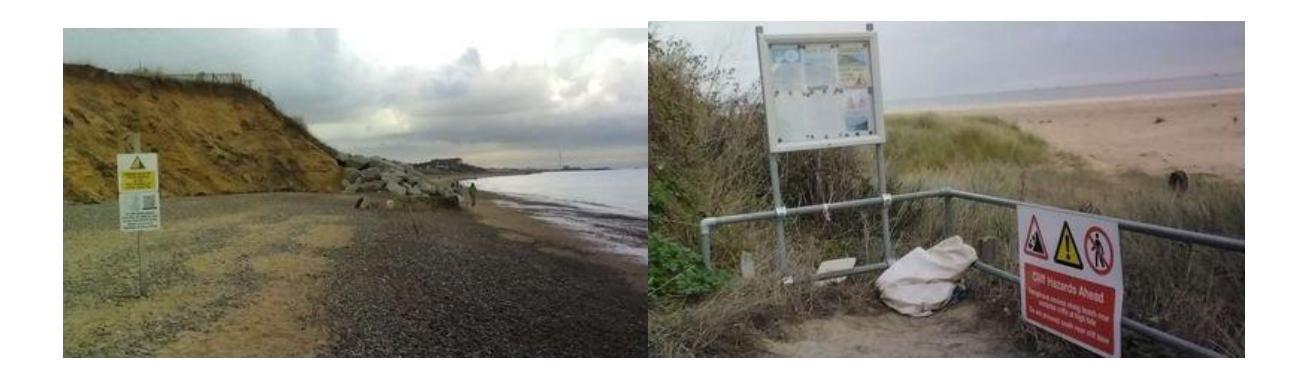
Photos of signage:

<u>Signage</u> Adequacy of signage: Adequate Provision of tidal information: Up to date & legible - Monitor

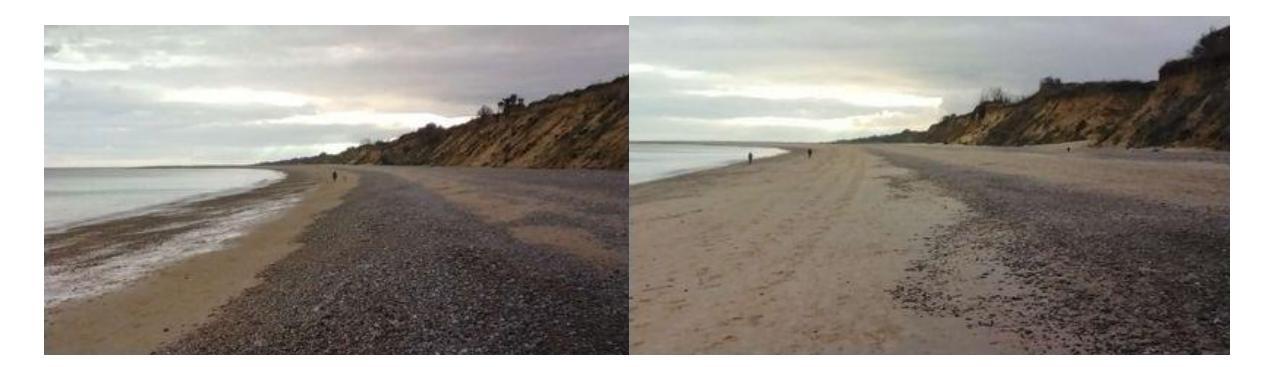
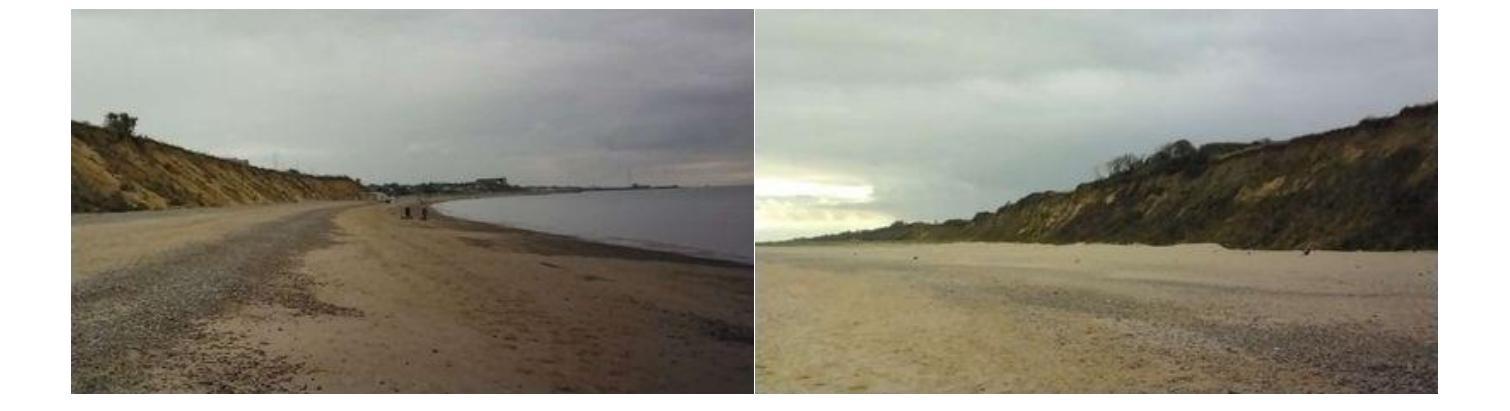
Photos of southern beach:

Southern Pakefield beach & cliffs General impression of beach volume: Moderately decreased

Comments on change to southern beach: As noted to the north, seas have on occasion reached above the MHWM and reprofiled the beach. A shingle berm of reduced prominence is consistent with that described to the north.

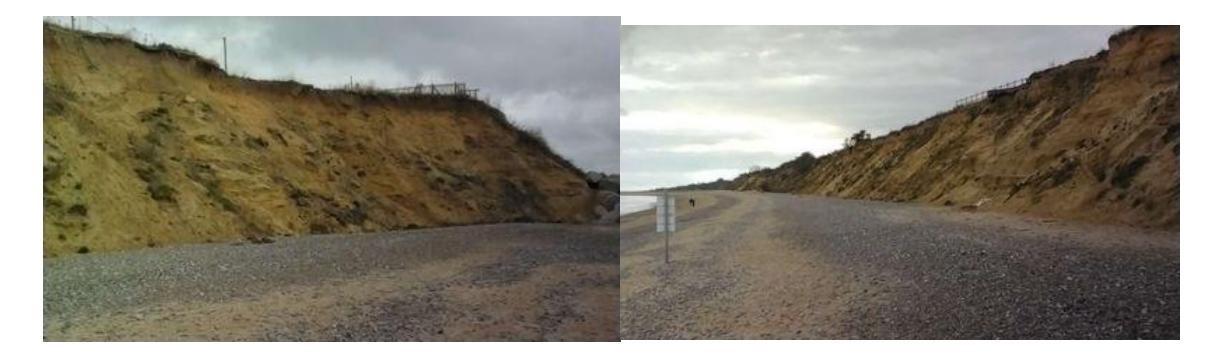
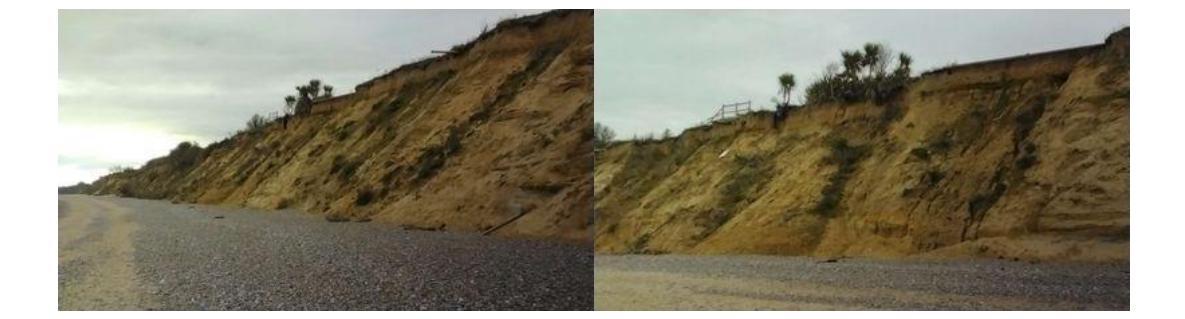
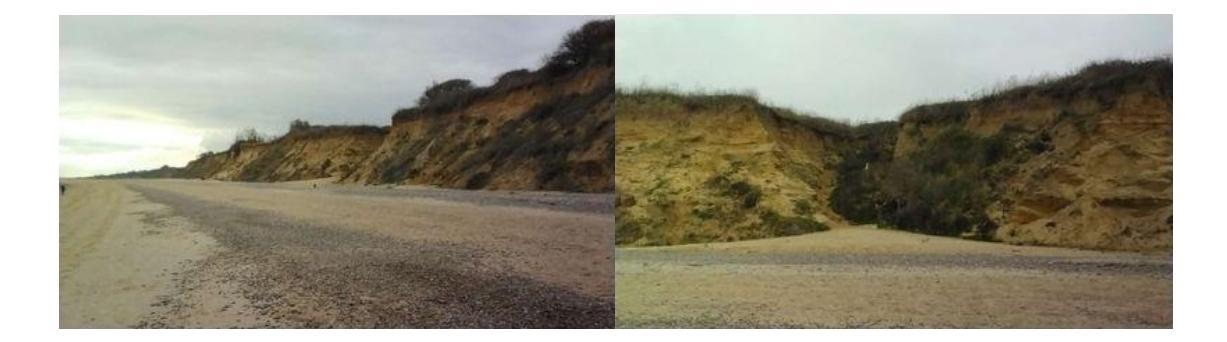
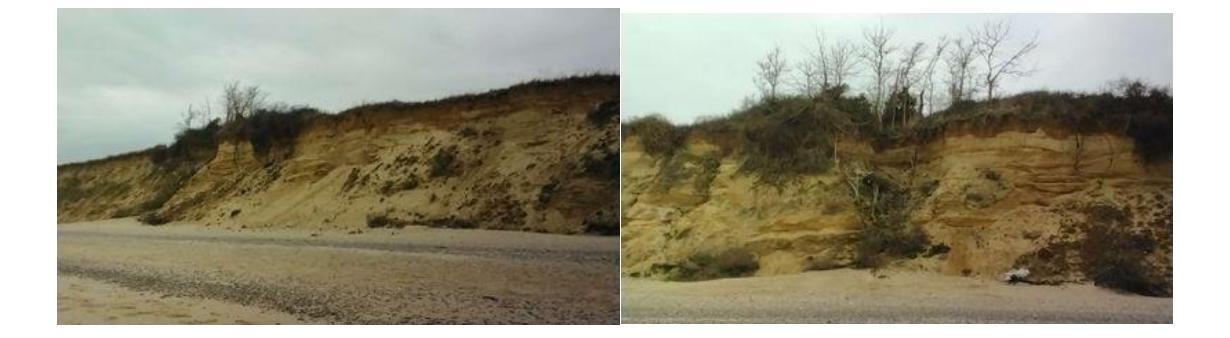
Photos of southern cliffs:

Changes to southern cliffs: Slumped material on cliff face; denuding and loss of vegetation; cliff-face steepening and overhanging; scree at base of cliff; fallen vegetation at base of cliff.

Comments on cliff change and any risk posed: Overall, the wider southern beaches have meant that the October sea conditions have been less significant in most areas than seen previously. Some of the cliffs however, have steepened faces and continue to realign through processes described previously. Rainfall amounts have not been extreme and the impacts on the cliffs have been relatively modest.

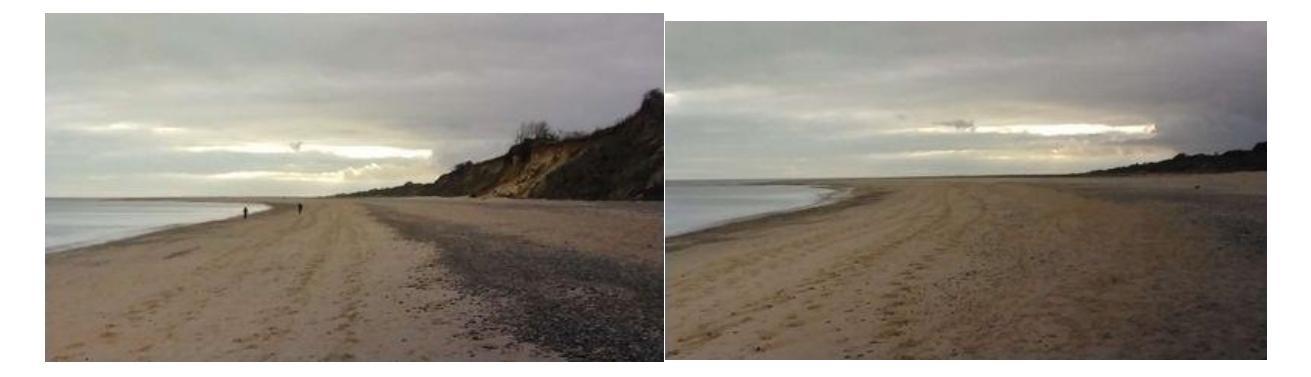
Photos of Pontins frontage and Benacre Ness:

Changes to beach geomorphology: Impression is that The Ness northward migration and gradual beach widening are continuing.

Comments on change at Benacre Ness: Noticeable volumes of wind-blown sand below the Pontins frontage and establishment of vegetation on the widened beaches. There was evidence of recent surface water discharge near the Pontins access but the flow was greatly reduced at the time of inspection. It has become less likely that subsequent outflow will reach the sea due to the increasing beach width.

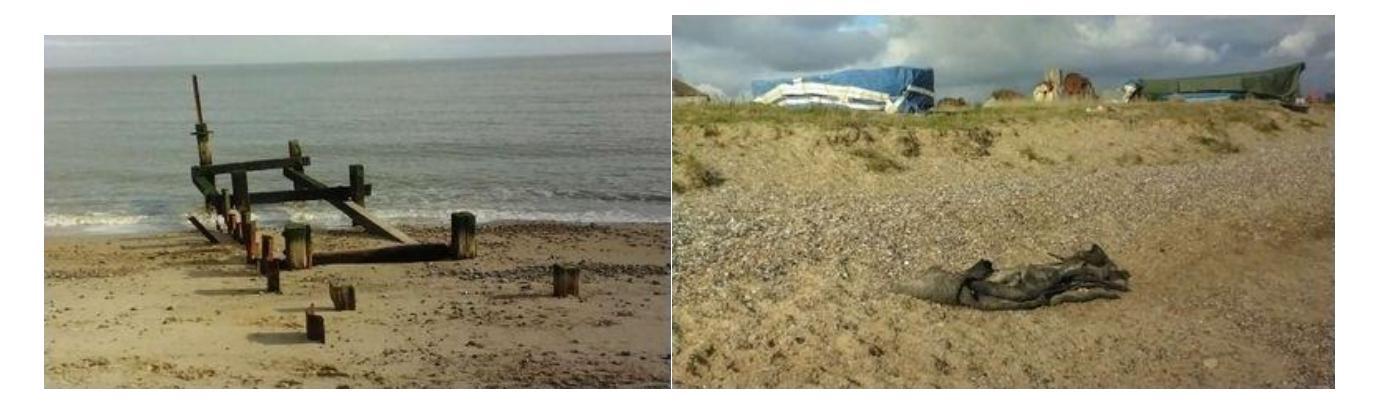
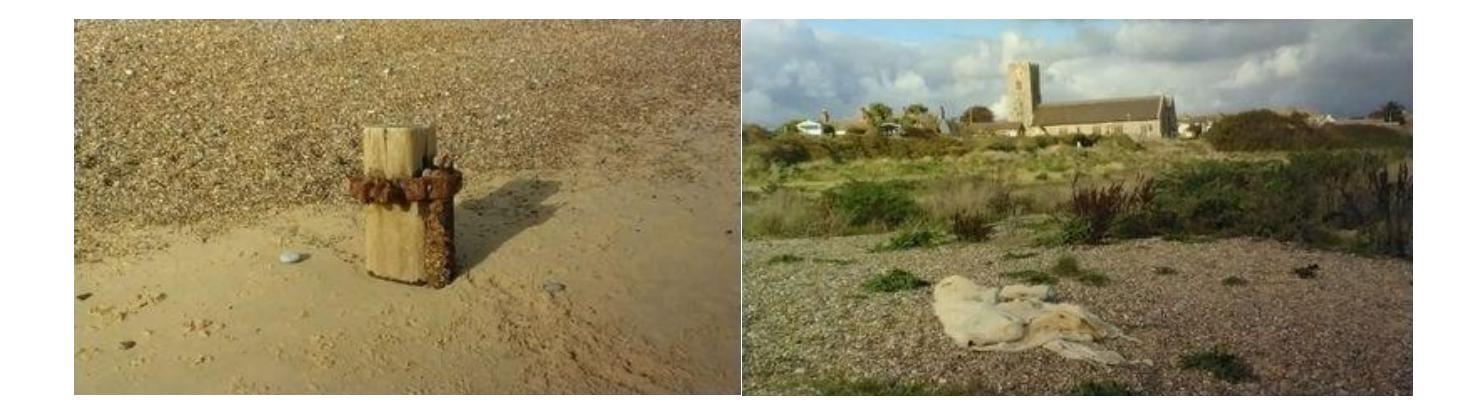
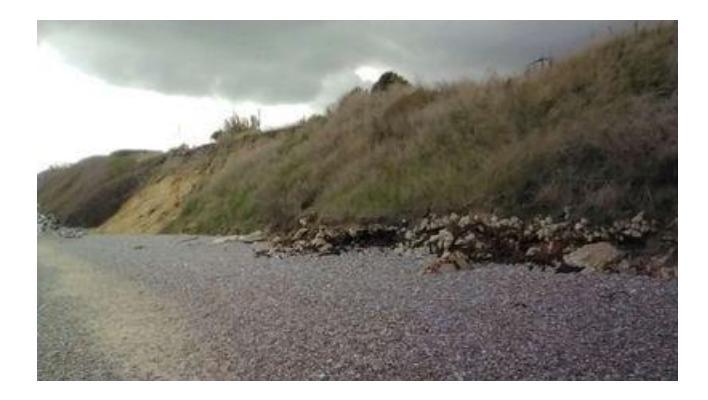
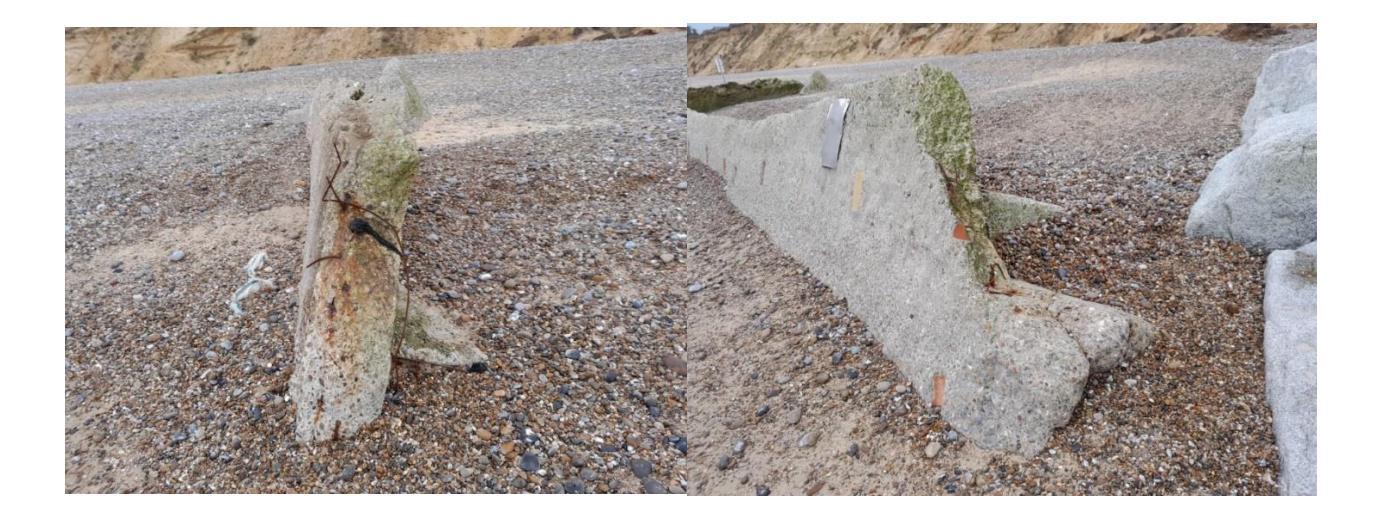
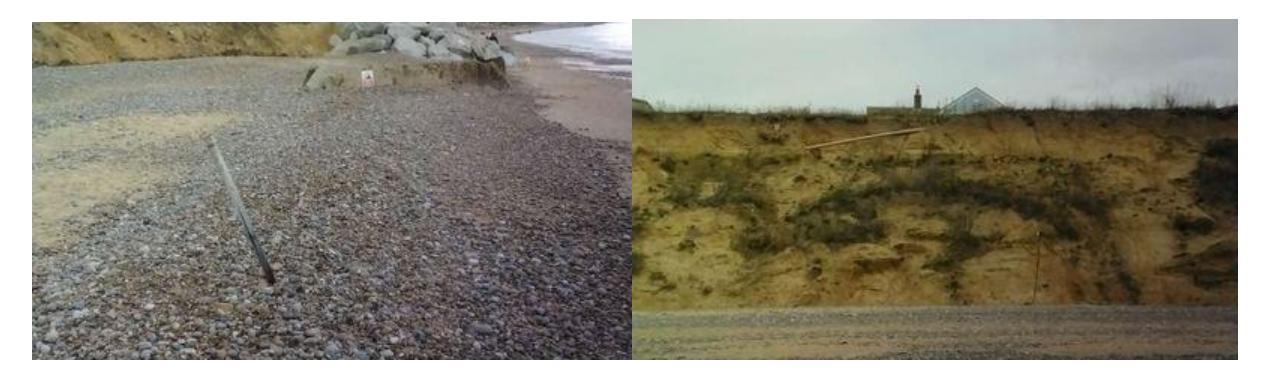
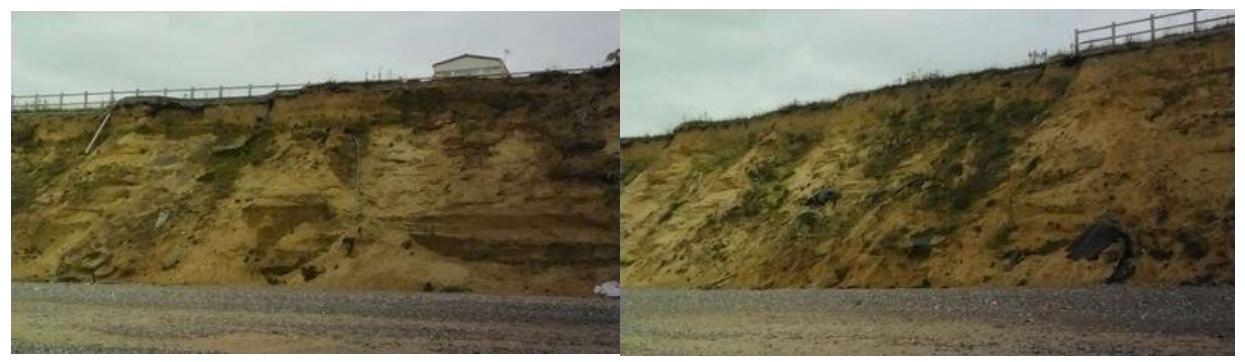
<u>Hazards and Debris</u> Photos of hazard/debris:

Comments on hazard/debris: Improvement works carried out at the base of the Arbor Lane beach access steps. CPE will be addressing the hazard posed by the wooden groynes through the repairs and maintenance programme and monitoring general debris.

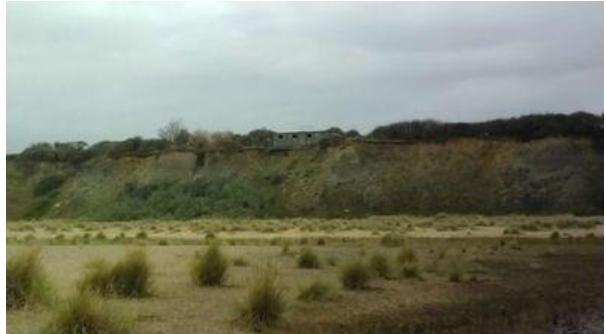
Changes in cliff stability: No obvious change viewing from beach. **Photo of cliff top structure:**
